**CAR PARK-REAR OF 33-34 PARK PLACE, CATHAYS,**

**CARDIFF**

**INITIAL BAT INSPECTION SURVEY**

**MARCH 2025**

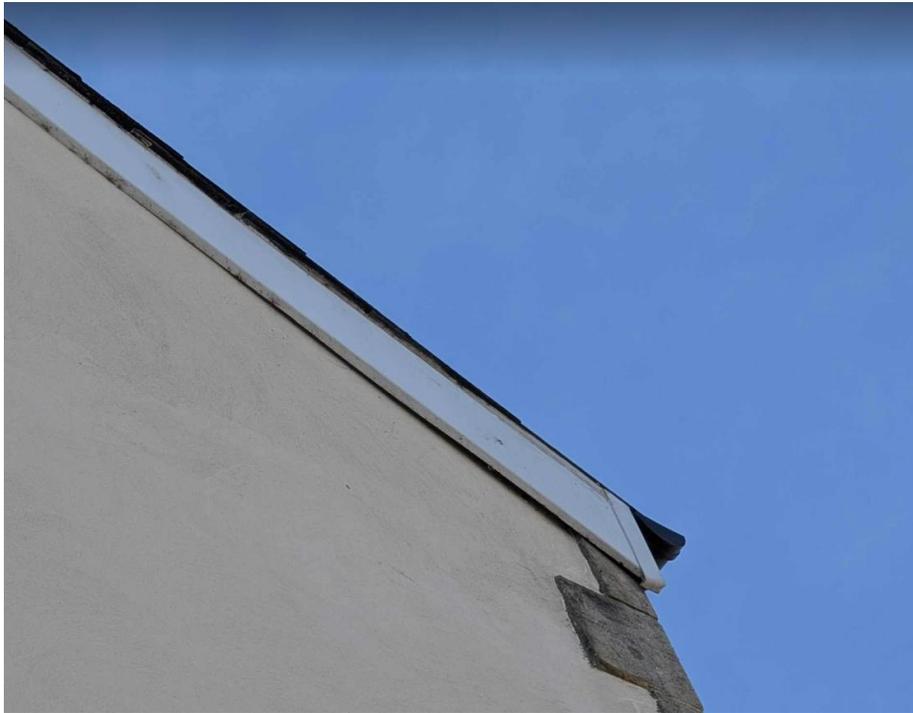
- A gap beneath the uPVC barge board of the pine end that the new building will abut

**Plate 1-Example of gap beneath barge board (area new building will abut)**

It is considered that due to the buildings architectural style, location and suitable access points, the building is of low potential for roosting bats. As such, at least one activity survey will be required between May and August to determine bat use at the site. This report will require updating on completion of the surveys.

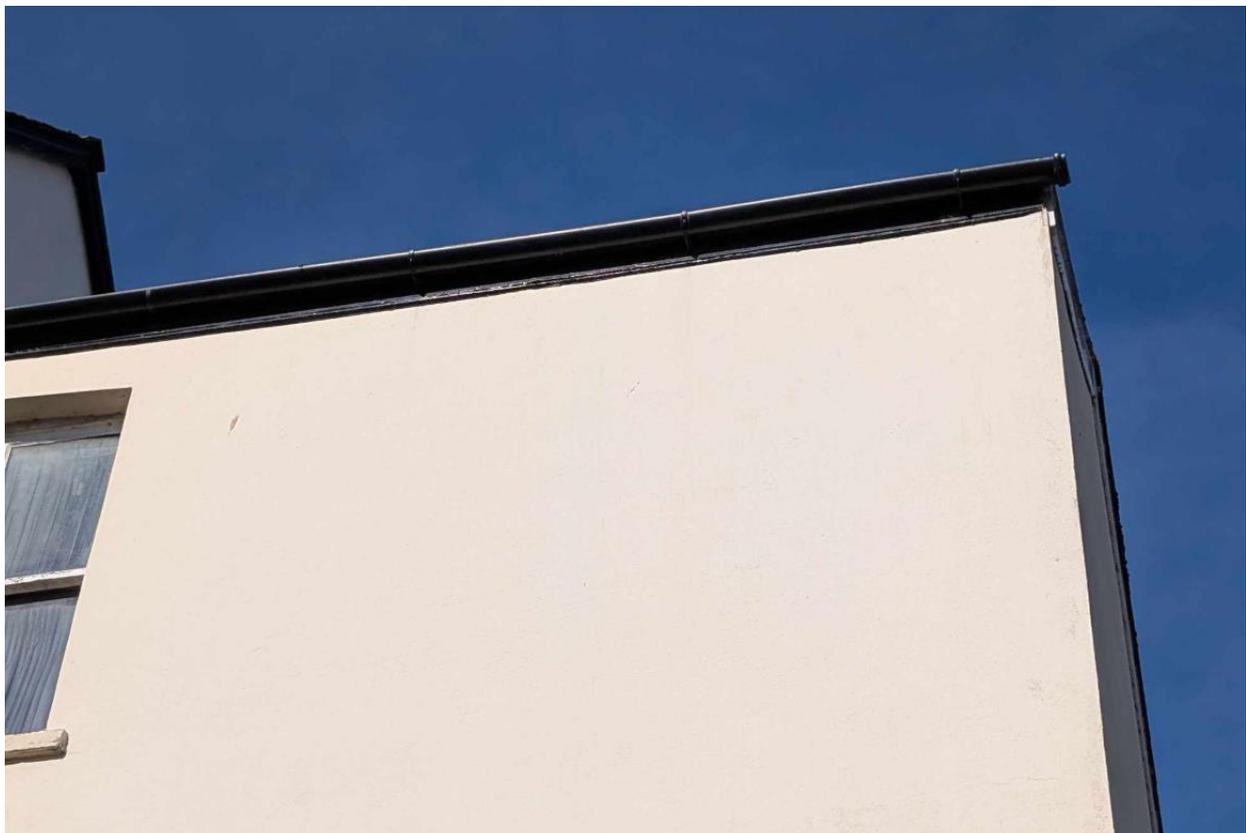
Generally, all other weather boarding appears to be in good order and relatively sealed. However, that said, the slates of the roof could not be viewed in any detail from the ground.

**Plate 2- relatively sealed fascia**

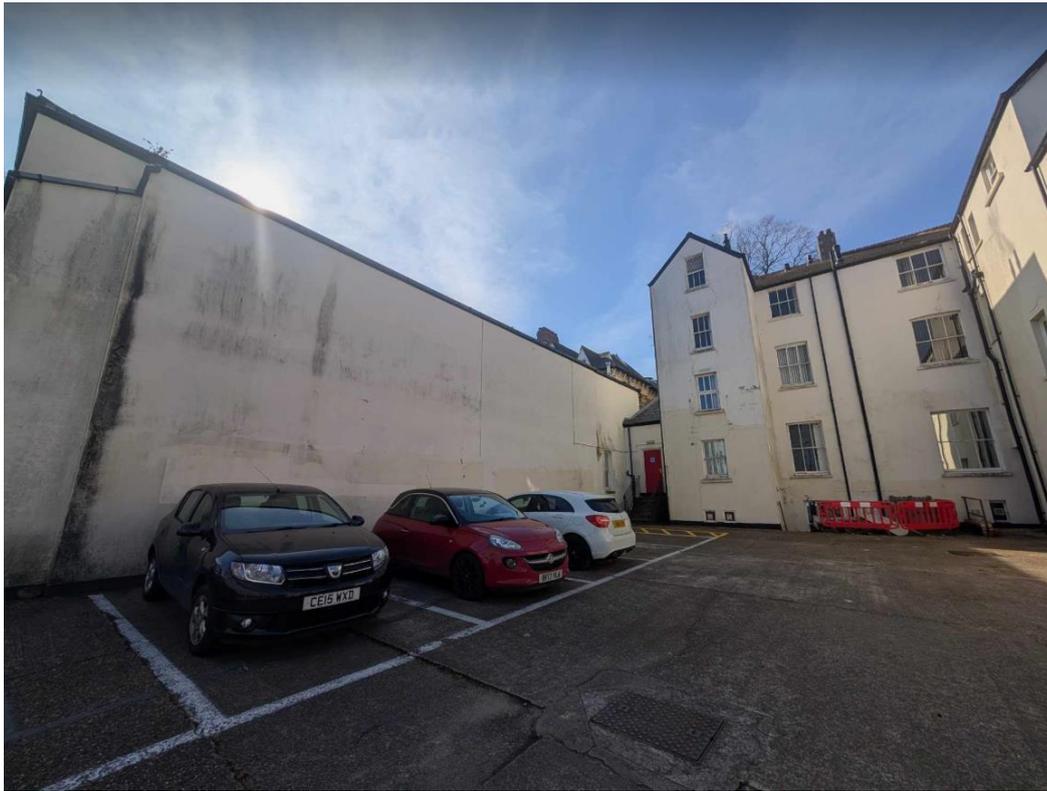
Plate 3- relatively sealed eaves of adjacent building
